**1985 Chevrolet Corvette V8-350 5.7L**

**M/T - Loss of Overdrive Operation**

Subject: LOSS OF OVERDRIVE - 4-SPEED MANUAL TRANSMISSION

Model and Year: 1984-85 CORVETTE

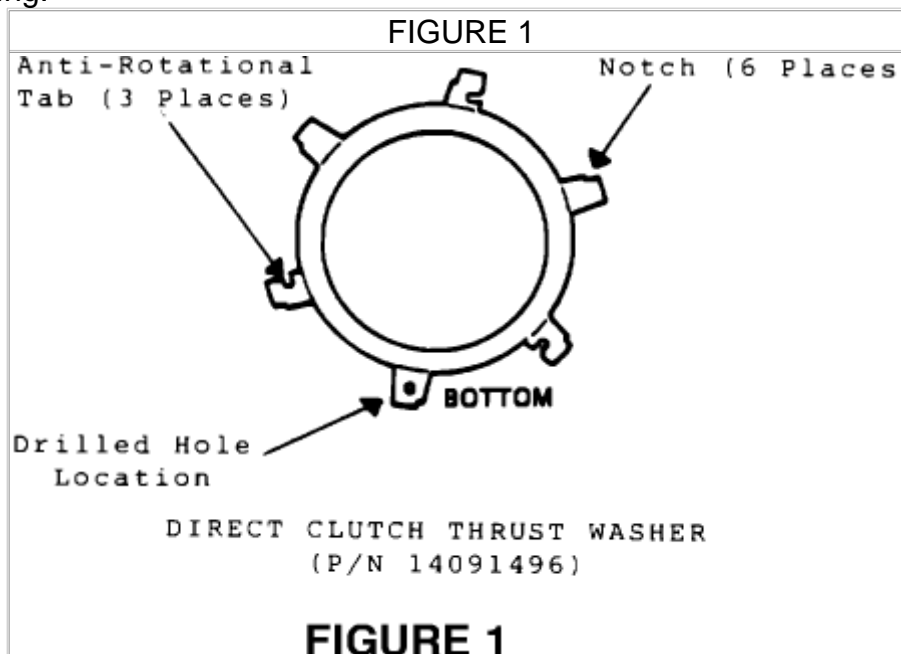
This condition may be caused by a hang-up of the direct clutch thrust washer if the washer groove in the overdrive unit's aluminum [case](#), the washer may then hang up in this groove | applying.

On transmissions beginning with serial number D4L 10837CD, a new direct clutch thrust washer (P/N 14091496) incorporates notches in all the tangs as well as anti-rotational tab: Figure 1) which prevent the washer from contacting the [case](#) wall.
