1985 Chevrolet Corvette V8-350 5.7L[Vehicle Level](#) → [Transmission and Drivetrain](#) → [Technical Service Bulletins](#) → [All Technical Service Bulletins](#) → [M/T - Noise With Automatic Overdrive Disengaged](#) ←**M/T - Noise With Automatic Overdrive Disengaged**[Notes](#)

85-111

Subject: NOISE IN DIRECT DRIVE 4-SPEED MANUAL TRANSMISSION

Model and Year: 1984-1985 CORVETTE

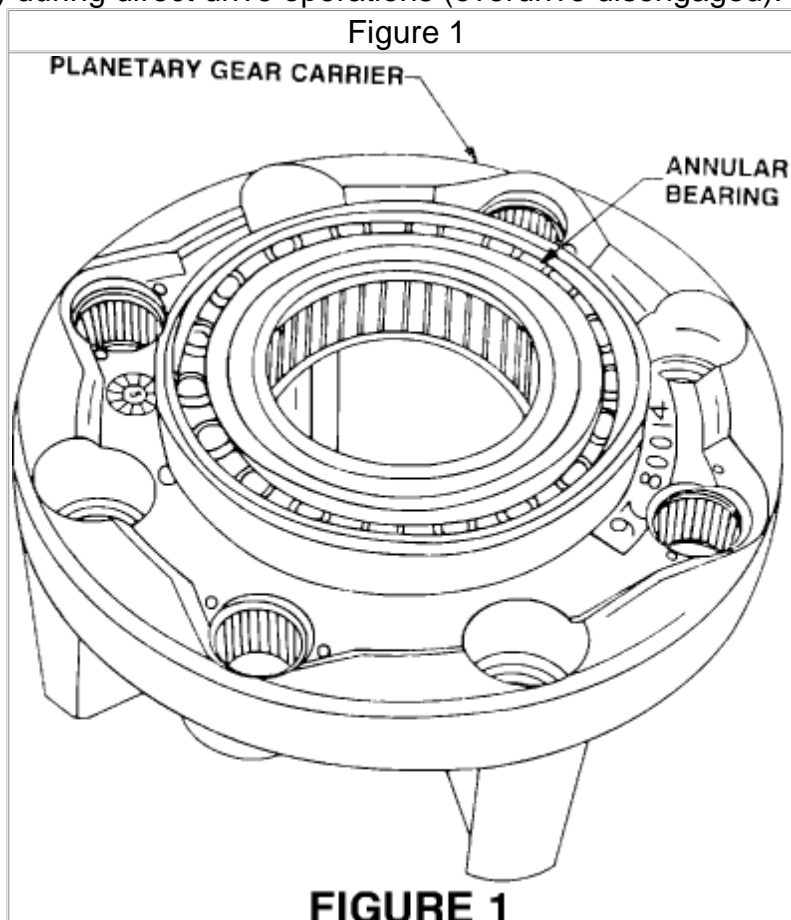
Some 1984-85 Corvettes equipped with the 4-Speed manual transmission with automatic overdrive may experience a noise in all gears (1st, 2nd, 3rd, and 4th) during direct drive operations (overdrive disengaged).

This condition may be caused by a worn annular bearing on the planetary gear carrier (see illustration). Continued operation of a noisy transmission in the direct drive mode will cause damage to the planetary carrier, adapter plate, input sun gear, and input sun gear oil seal. If the input sun gear oil seal is damaged, it is possible for overdrive unit oil (Dexron II) to leak into the manual portion of the transmission.

On transmissions beginning with serial number D5C 14413 CF, a new planetary gear carrier has been released. This carrier (P/N 14094571) incorporates an annular bearing with increased thrust capacity.

Complaint vehicles will have transmissions built prior to serial number D5C 14413 CF. These transmissions are to be repaired by disassembling the overdrive unit according to the appropriate section in the Vehicle Service Manual to enable the following to be carried out:

1. Inspect the adapter plate surface, input sun gear, and input sun gear oil seal for damage. If there is indication of damage, the adapter plate, input sun gear, and input sun gear oil seal should be replaced. If there is no sign of damage, these parts may be reused.
2. If debris is present in the overdrive unit, completely disassemble and clean the unit, including the [valve body](#).

3. If there is evidence of oil intrusion from the automatic overdrive unit into the 4-speed manual unit, the manual unit should be drained and flushed also.
4. Replace the planetary gear carrier with the new, P/N 14094571, carrier.
